DELAWARE VALLEY Honeywell Route 13 (Delaware County) Claymont, DE

WORKS FACILITY

SWMU 15 TEST PIT LOCATIONS AND CROSS SECTIONS WITH ORGANIC COMPOUND ANALYTICAL EXCEEDANCES

Figure 8

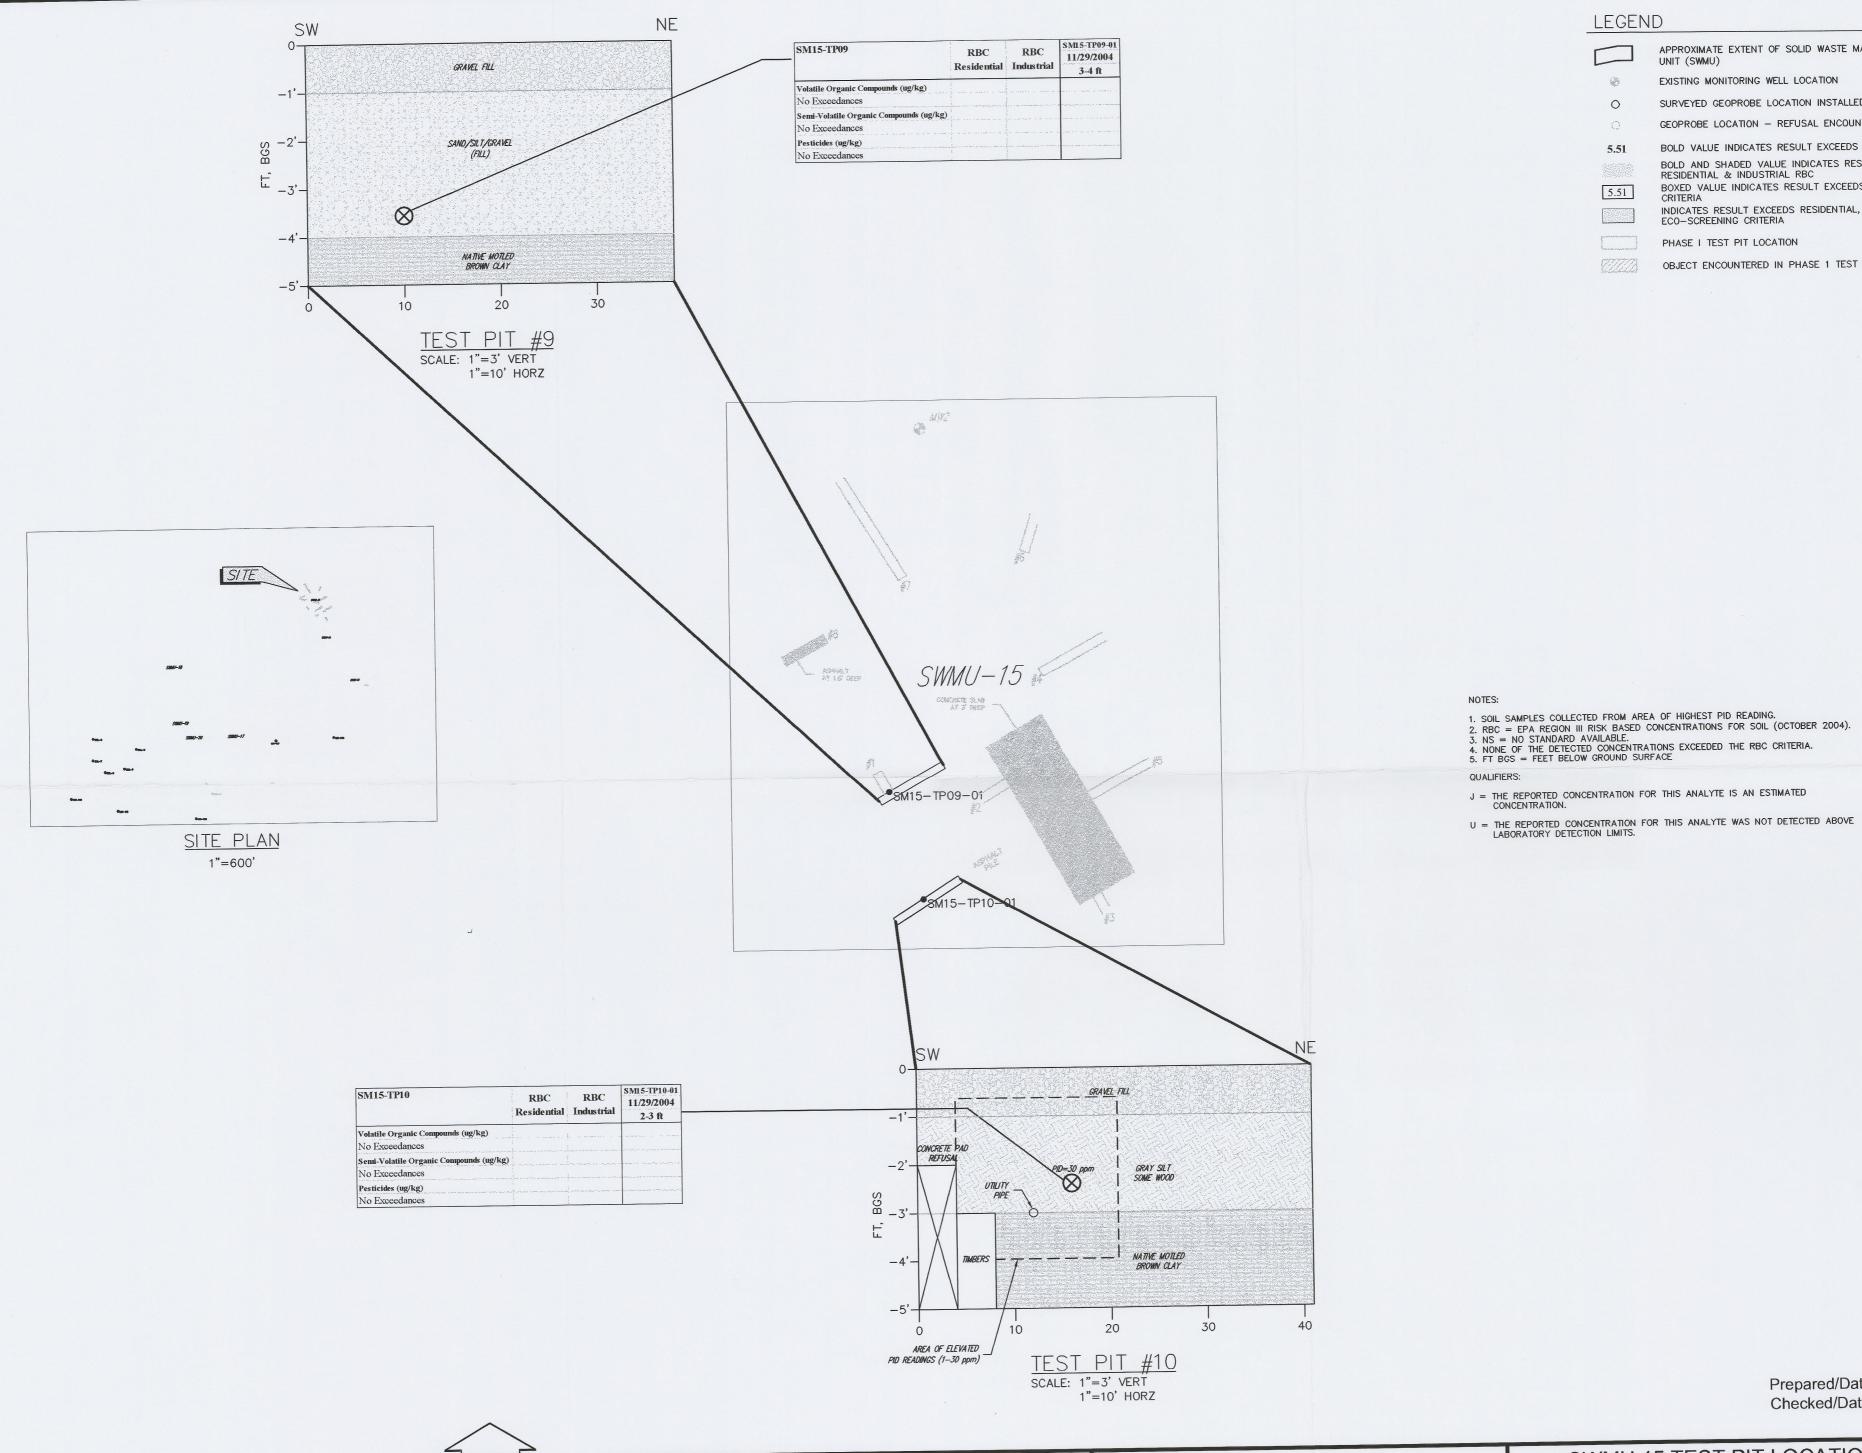
BOLD VALUE INDICATES RESULT EXCEEDS RESIDENTIAL RBC BOLD AND SHADED VALUE INDICATES RESULT EXCEEDS RESIDENTIAL & INDUSTRIAL RBC

BOXED VALUE INDICATES RESULT EXCEEDS ECO-SCREENING

INDICATES RESULT EXCEEDS RESIDENTIAL, INDUSTRIAL RBC & ECO-SCREENING CRITERIA

OBJECT ENCOUNTERED IN PHASE 1 TEST PIT
